The collapse in the New, Lower Vinstra II hydropower tunnel

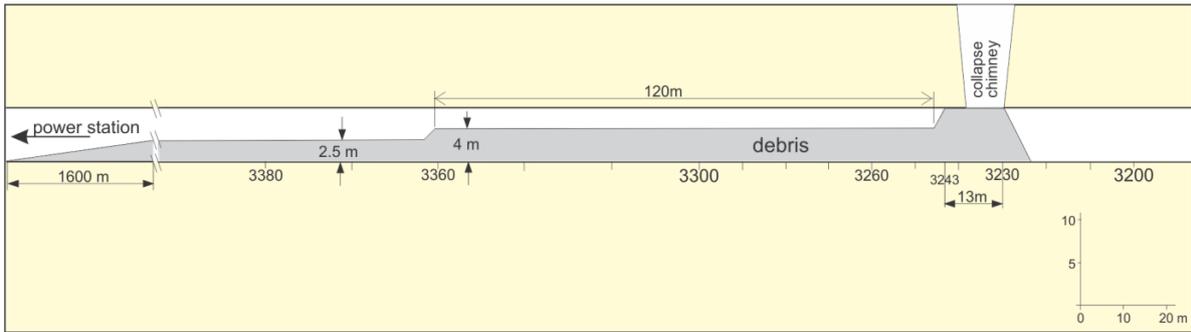
Major quantities of loose materials with grading from sand and gravel to large boulders were found distributed from the sand trap towards the failure. 1700 m from the collapse, boulders of size 2.0 - 2.5 m³ were found. 13 m downstream of the collapse the debris reached the tunnel roof, preventing access further upstream, see Figure 2. Many of the pieces in the debris were thin slabs with a very smooth, polished (slickenside) fragments, as are shown in Figure 3.

Figure 2: The debris in the tunnel, reaching 2.5 km almost to the underground power station

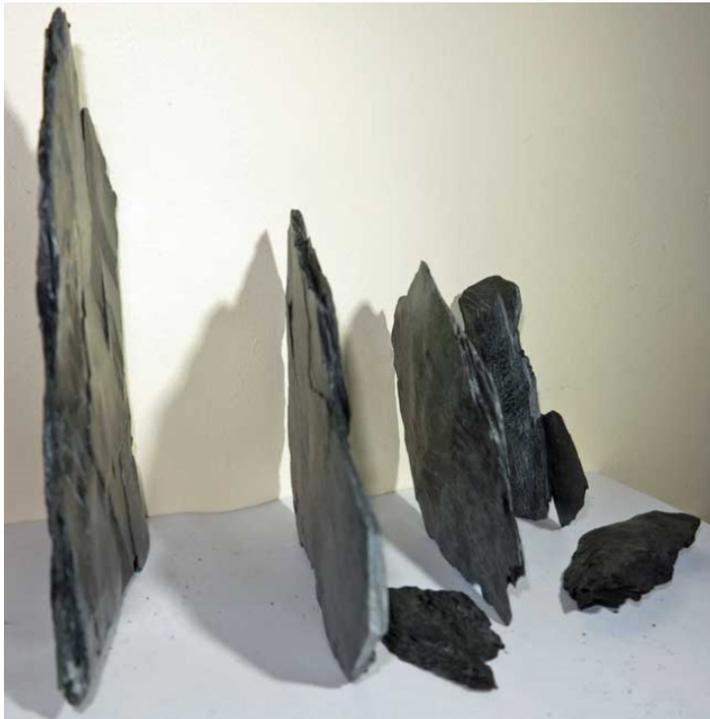
Figure 3: Photos of slabs from the Vinstra collapse in 1991. The thin slabs are polished with a coating of talc and graphite. The friction along such surfaces is very low when inundated.

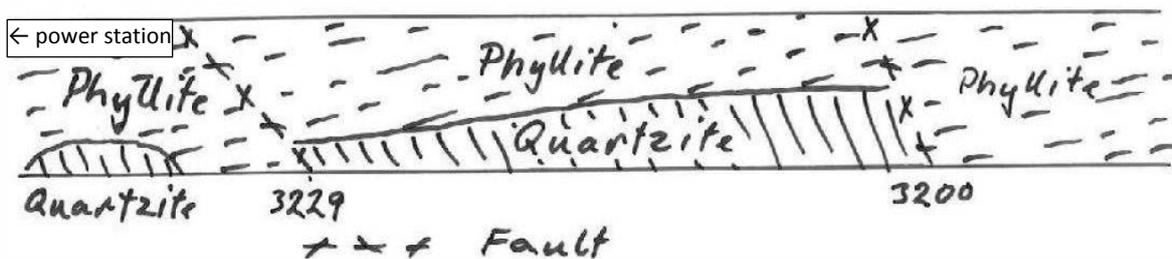
The width of the failure zone at chainage 3,229, was 15 - 20 m, measured along the tunnel, see Figure 4, in which two faults are shown, both with strike almost perpendicular to the tunnel axis. The most pronounced one at chainage 3,230 had about 0.75m thick central core with clayey, weak material. Also the surrounding rocks were weak. Slickensides and graphite coatings were commonly found on weakness planes.

Figure 4: Right-hand wall in tunnel, with faults at chainage 3200 and 3229. Sketch made during tunnel construction. The collapse occurred at chainage 3230.

The rock support installed was rock bolts and shotcrete in roof and walls to 2.5m above the invert. During cleaning of the invert, before first watering up, it was found that the rock was weak and in the central, clayey part of the zone excavated to a depth of about 1.5 m below the shotcreted part in the walls. No support was installed in the invert and in the lower part of the walls.

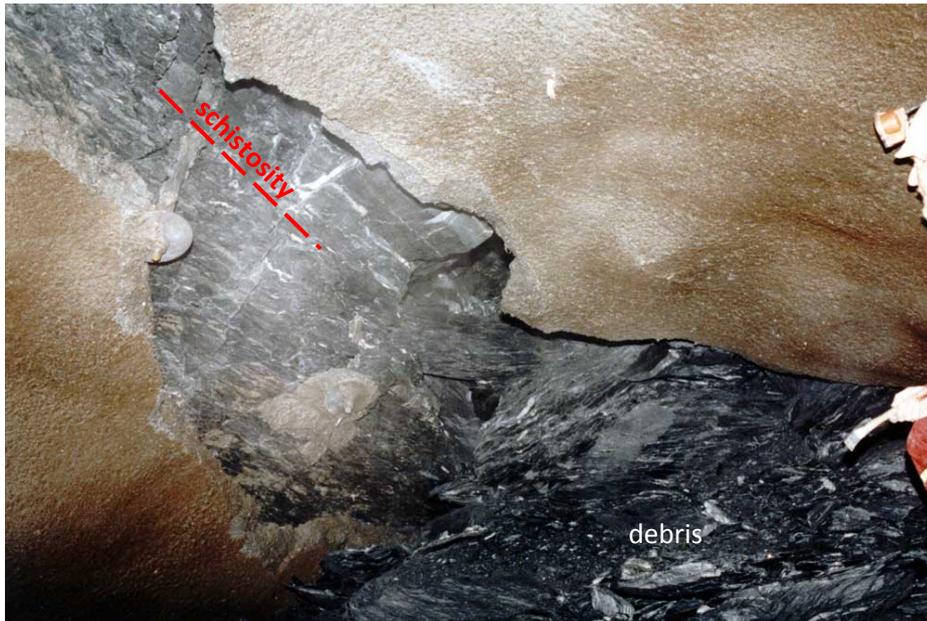
Figure 5: The conditions just upstream of the collapse. The schistosity planes with slickensides and graphite

Observations in the headrace tunnel upstream of the collapse found that clay fillings in many faults/weakness zones had been washed or slid out sometimes to a depth of 2 - 3 m. Other location with similar conditions that had been supported by shotcrete showed no signs of cracking or damage. This indicates that the collapse had started in the unsealed parts of the zones of weak, clayey⁵ rock which had been left without any protective support. Softening of the clayish material and reduced friction properties after inundation were probably the main causes.

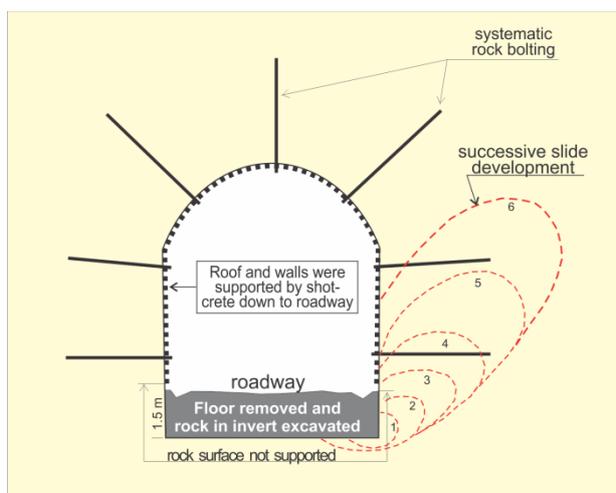
Due to the softening of the clayey material and erosion by the water flow, the size of the tunnel here was increased resulting in sliding and collapses until the debris filled most of the tunnel profile downstream of the collapse area and almost blocked the water flow. It was concluded that if the shotcrete had been installed in the whole wall and in the invert, sealing of the loose materials, the collapse could have been avoided.

Figure 6: Possible development of the failure, mainly in the right side (looking downstream)

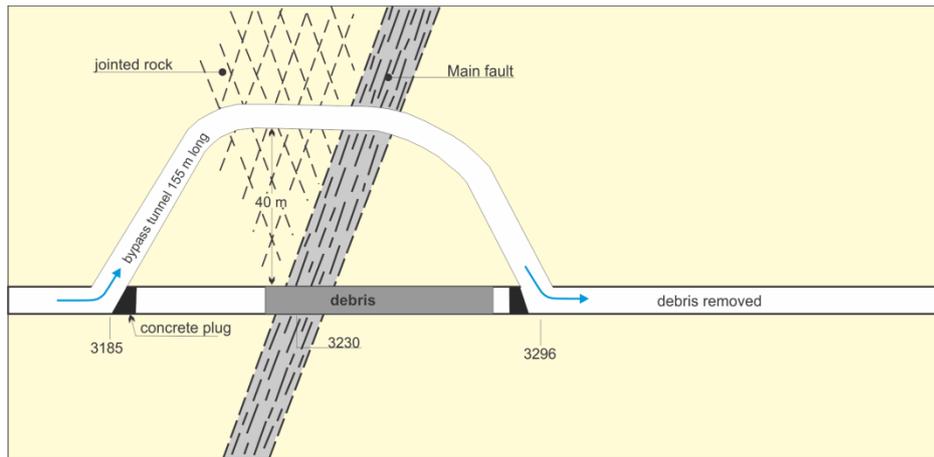
Figure 7:
The 155 m long bypass
tunnel around the
collapsed section

The chosen support design of the upper by-pass tunnel (Figure 7) was a combination of sprayed concrete with thickness 0.15-0.25m, sprayed concrete ribs and rock bolts (dowels). The tunnel invert was concreted.
